Technical note

Inspection of Fabricated Fuselage Panels Using Electronic Shearography

July 1992

DOT/FAA/CT-TN92/26

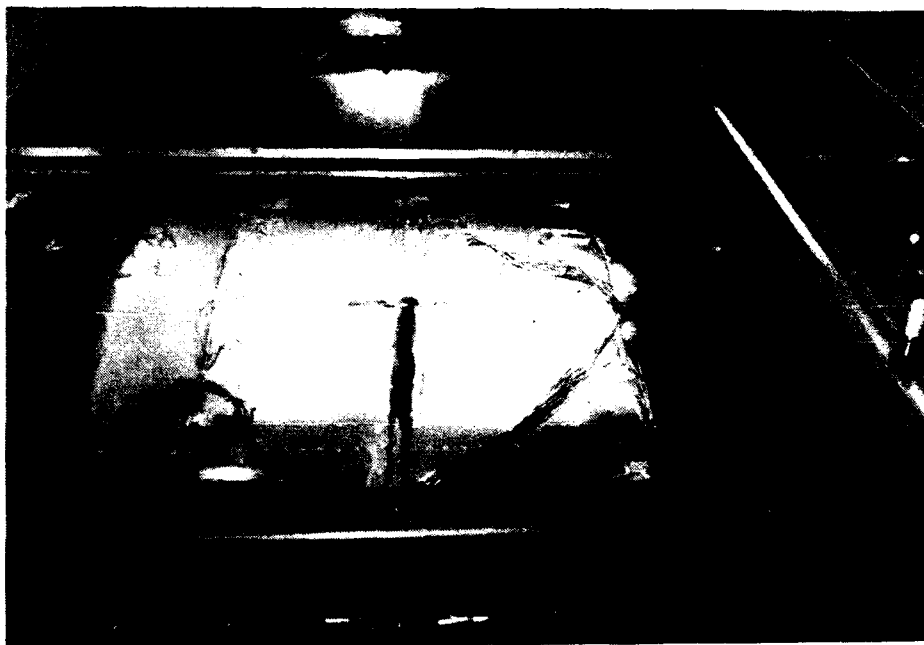
Test Series No. 2 was designed to test the capability of the electronic shearography to detect a mid-bay crack. The shearography equipment was set up as in Test Series No. 1, with the camera mounted on the fixture frame and not in direct contact with the panel. Into the original control test panel of Test Series No. 1, a crack was placed in the mid-bay area between x2 and x3 in the axial direction as previously shown in figure 3. Foster-Miller personnel started the crack by cutting a 10-inch long slice in the panel centered around frame F3 with a dremel saw. The panel was then fatigue cycled to sharpen the crack at both ends. About 200 cycles from 0-5 psi were required to grow the crack to about 0.0625 inches on each side. Putty on the underside of the panel prevented the pressurized water from coming through the crack, although some water leaked out around the tear strap attachment point (see figure 16).

FIGURE 16. PHOTOGRAPH OF TEST PANEL NO. 1 WITH 10-INCH MID-BAY CRACK SHOWN HORIZONTALLY IN THE CENTER.

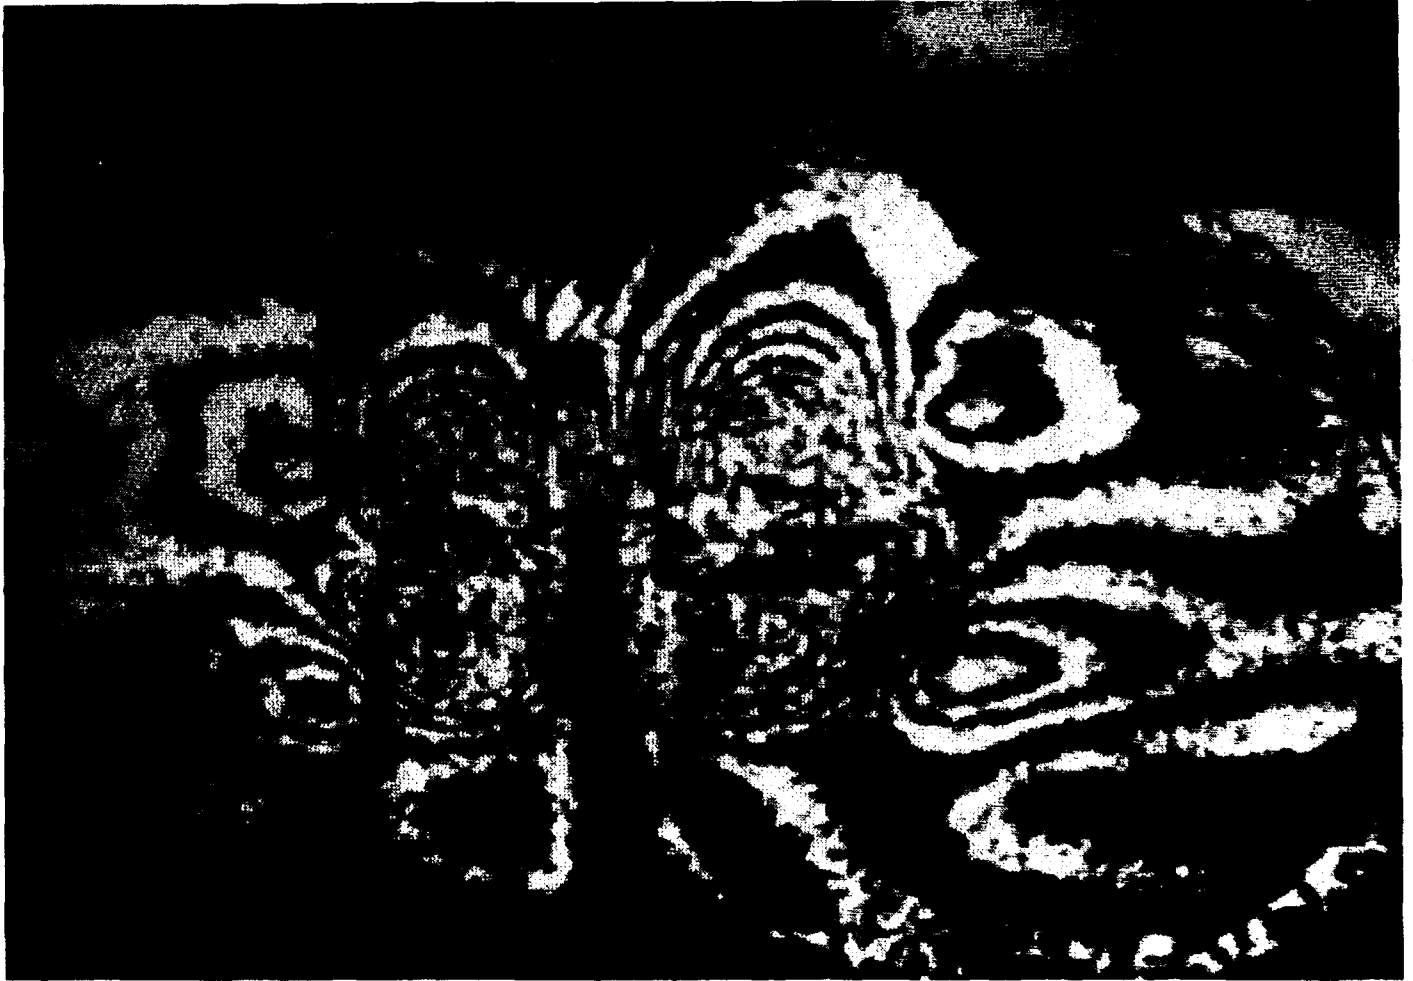
FIGURE 18. HIGH STRAIN SEEN OVER MID-BAY CRACK WITH 0.01 PSI DIFFERENTIAL STRESSING PRESSURE IN THIS X-VECTOR SHEAROGRAPH. FIELD OF VIEW IS 18 x 26 INCHES.

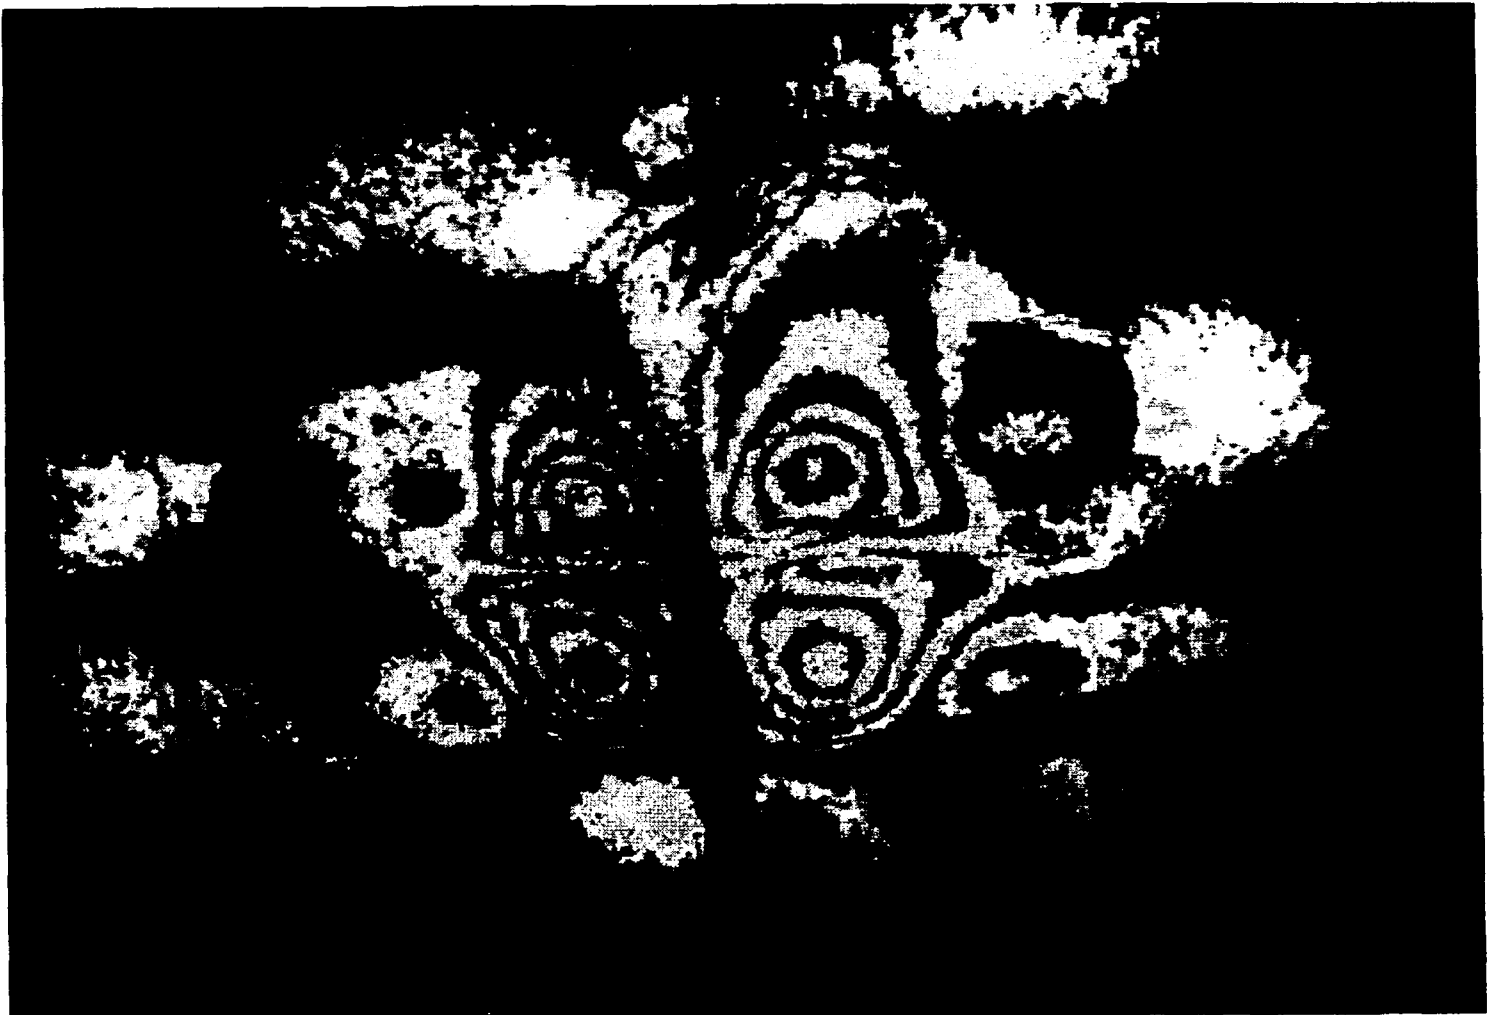
The crack was inspected with X-vector shearing initially at 0.01 psid stress level as described above. The indicated strain was more than was required for detection, so the inspected differential pressure was reduced to 0.005 psid (see figure 19), while shearing in the X-vector. This reduced the number of fringes in half producing a stress level that was one-sixth that of the first test series. Even the high strain internal structures such as the tear straps were barely visible.

FIGURE 19. X-VECTOR SHEAROGRAPH of MID-BAY CRACK AT 0.005 PSI DIFFERENTIAL STRESSING PRESSURE. THE CRACK IS ORIENTED HORIZONTALLY WITH THE CRACK TIPS SHOWING AS SHARP POINTS BETWEEN EACH VERTICAL FRINGE PAIR. FIELD OF VIEW IS APPROXIMATELY 20 x 30 INCHES.

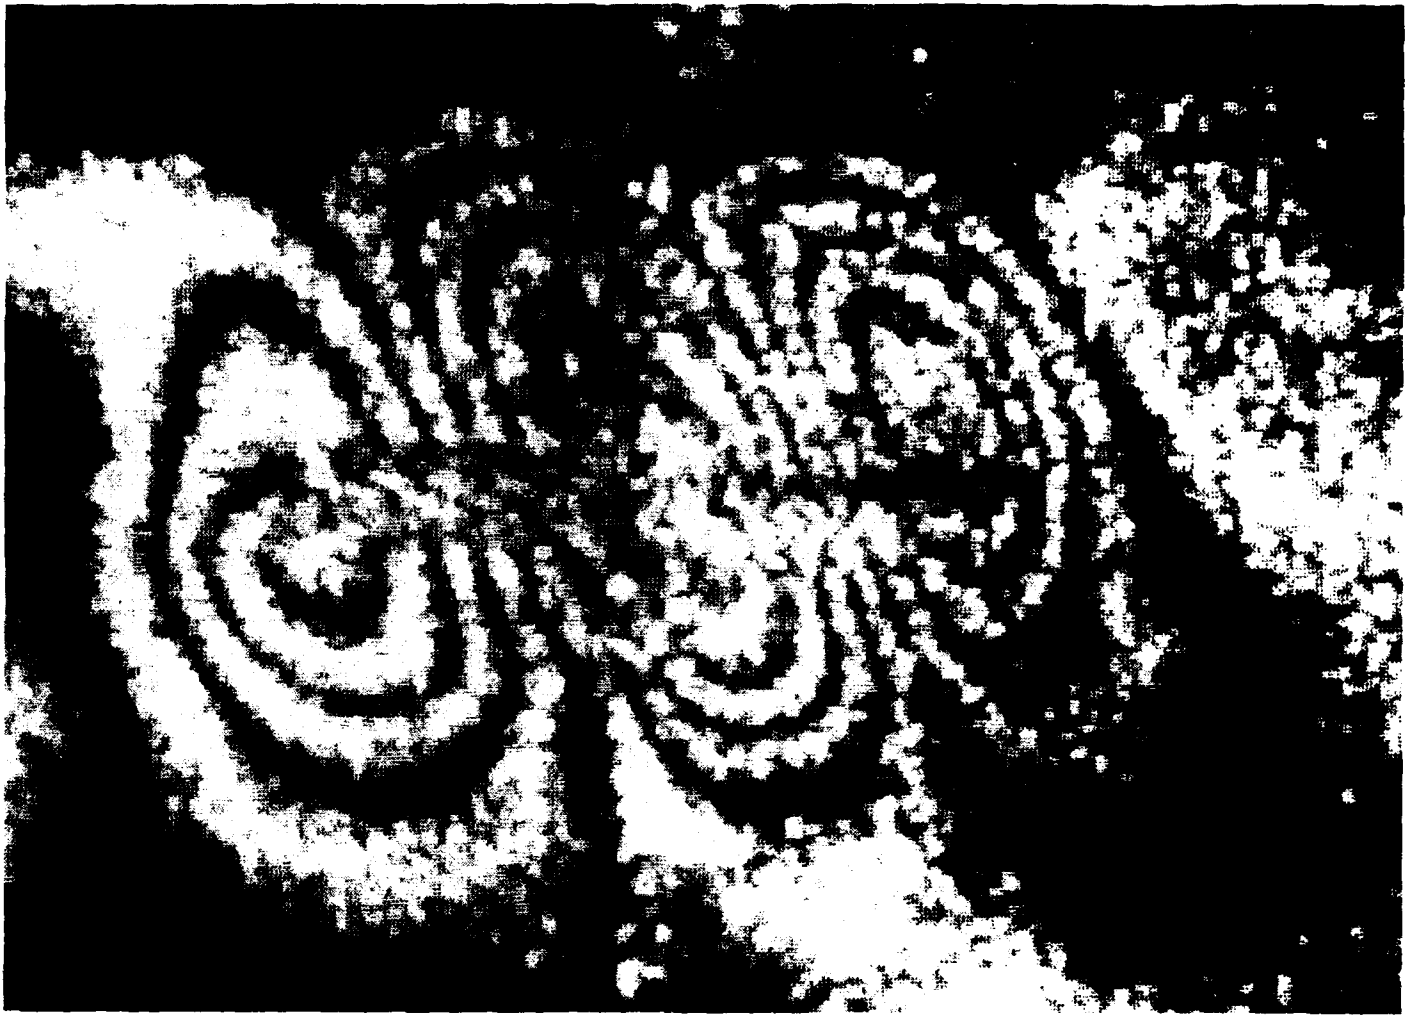
The inspections continued with 45-degree vector shearing as shown in figure 20 and with Y-vector shearing as shown in figure 21. Note that the number of strain concentration fringe pairs in the shearographic images increased from two in X-vector shearing (figure 21) to three in the 45-degree vector of figure 20 and the Y-vector shearing shown in figure 21. This effect showed the crack opening up from the hoop stress, coupled with the tear strap in the center trying to hold the crack together. The shearographic images can all be related to the live image of the crack area shown previously in figure 17, although the shearography images of the strain patterns cover nearly twice the

FIGURE 20. IMAGE OF A 45-DEGREE VECTOR SHEAROGRAPH SHOWING STRAIN CONCENTRATIONS AROUND THE MID-BAY CRACK. THIS IMAGE WAS TAKEN AT A 0.005 PSI DIFFERENTIAL STRESSING PRESSURE WITH A FIELD OF VIEW OF 13 x 19 INCHES.

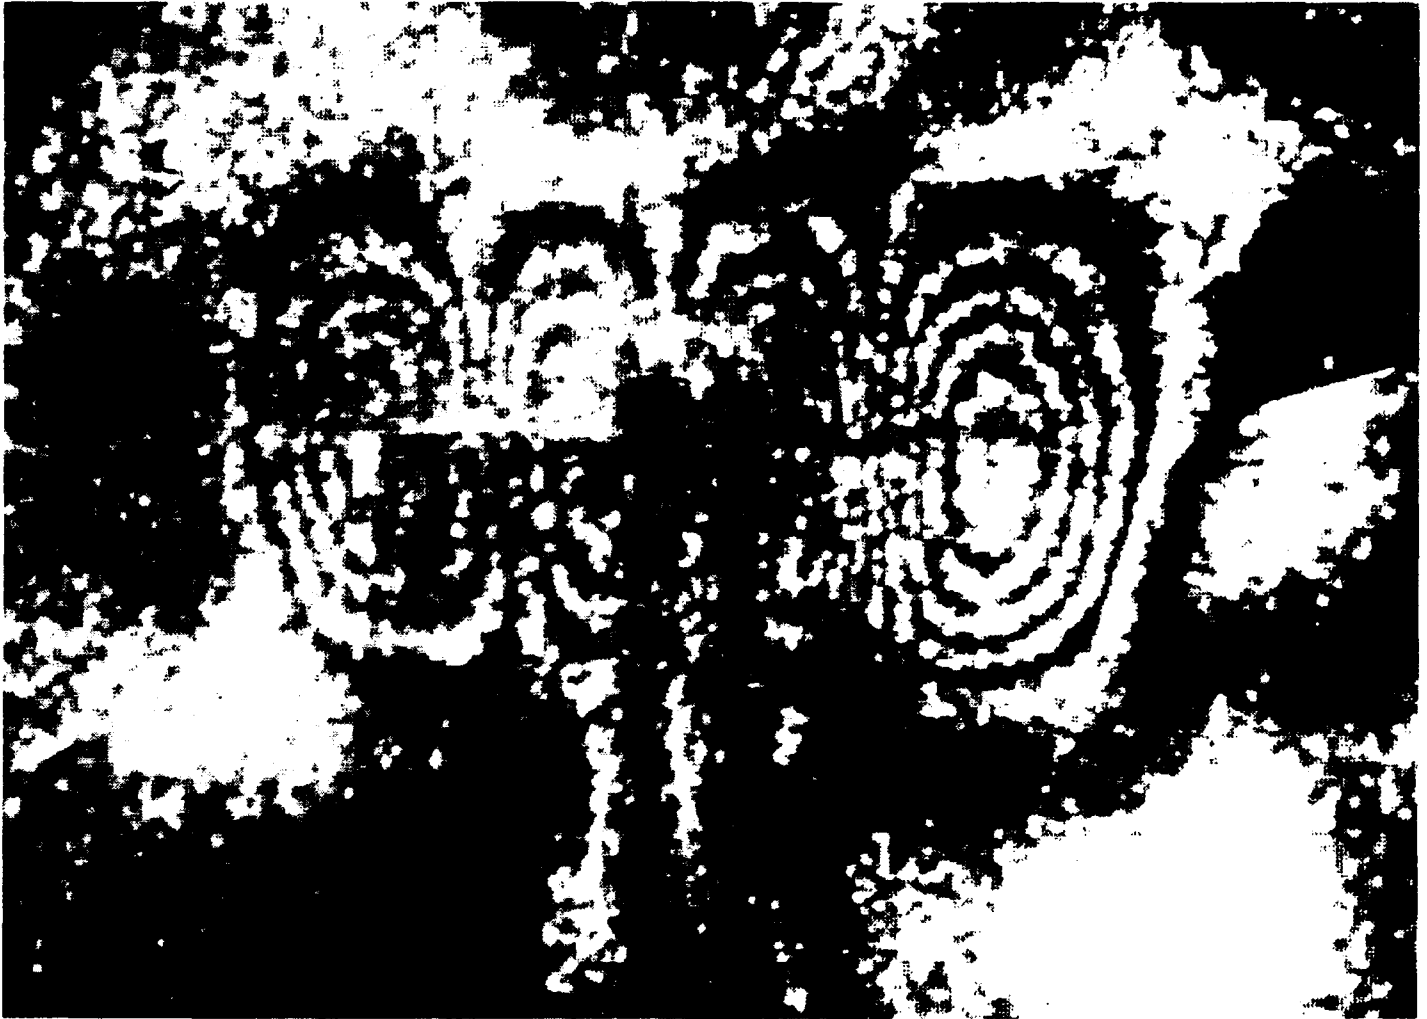
FIGURE 21. Y-VECTOR SHEAROGRAPH AT 0.005 PSI DIFFERENTIAL PRESSURE, SHOWING STRAIN CONCENTRATIONS AROUND THE MID-BAY CRACK. THE DOUBLE SETS OF FRINGE PAIRS INDICATE THAT THE TEAR STRAP IS TRYING TO HOLD THE CRACK TOGETHER. FIELD OF VIEW IS APPROXIMATELY 16 x 24 INCHES.

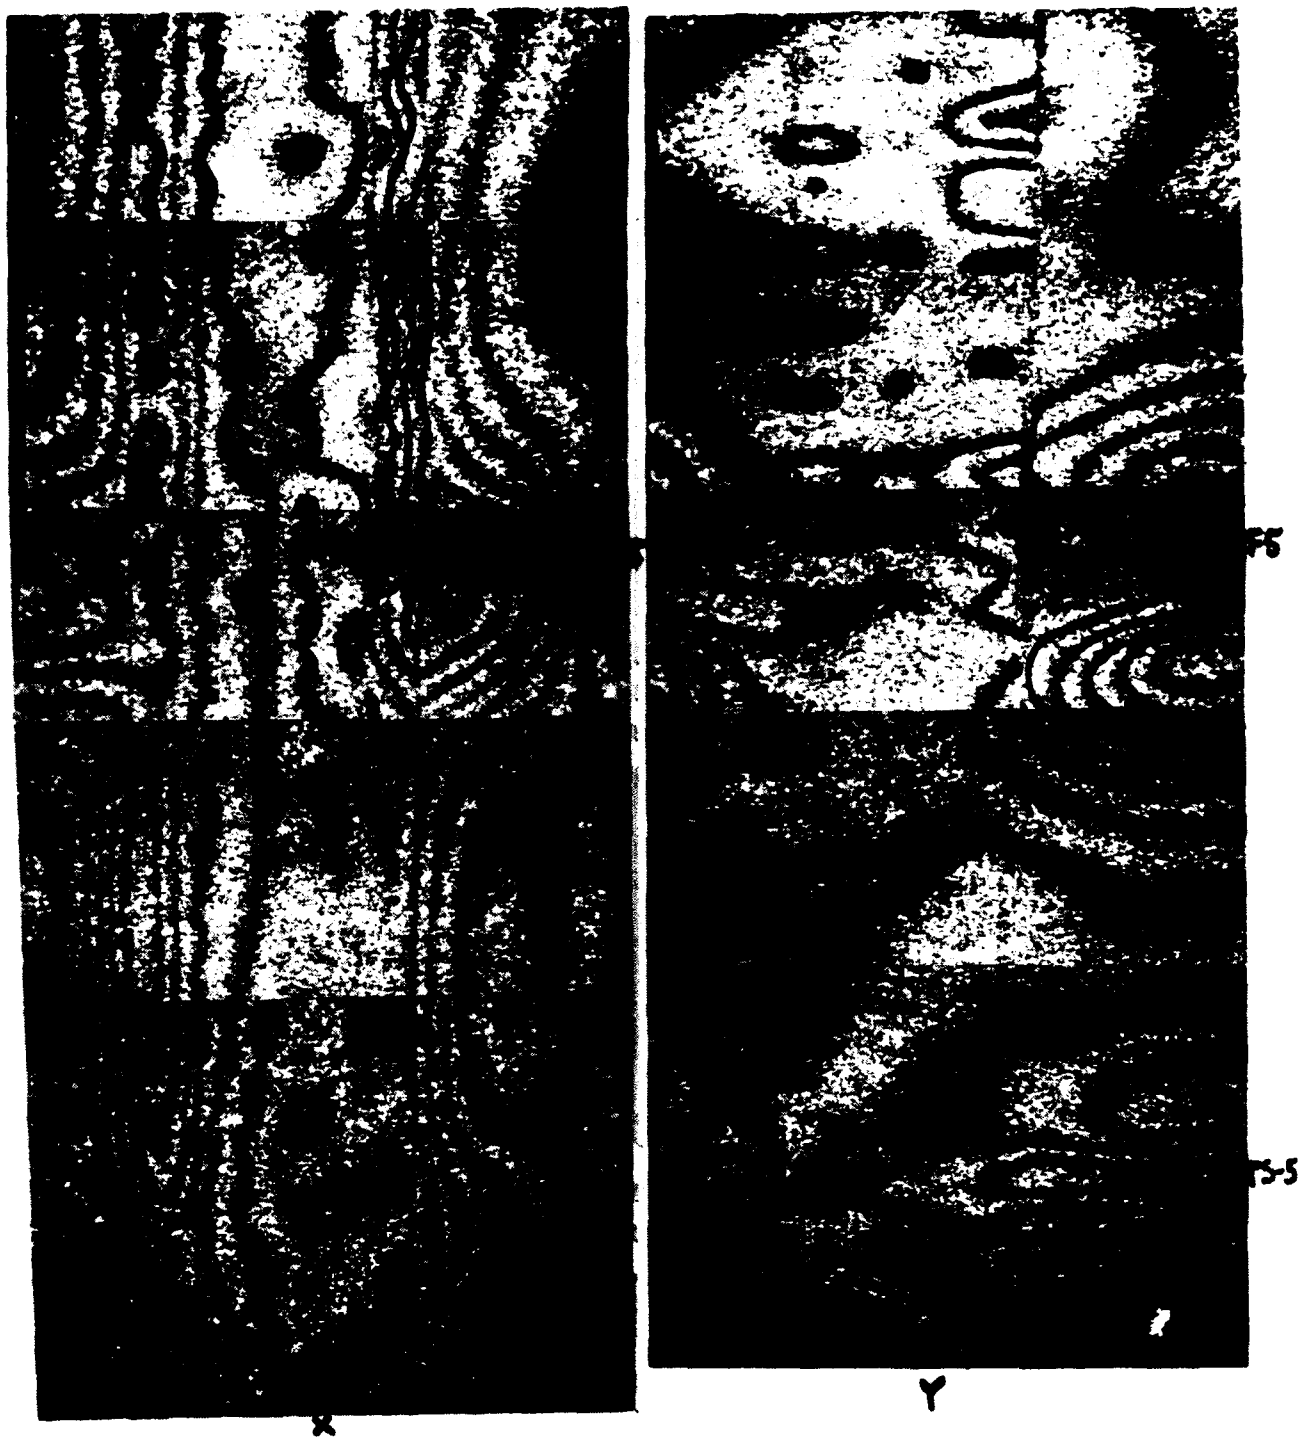
FIGURE 25. FIRST SECTION OF LAP JOINT INSPECTED DURING TEST SERIES NO. 3 SHOWING BONDED AND DISBONDED AREAS. LEFT SIDE IMAGE IS OF THE X-VECTOR SHEAROGRAPH AND THE RIGHT SIDE IMAGE SHOWS THE Y-VECTOR SHEAROGRAPH OF THE SAME SECTION.

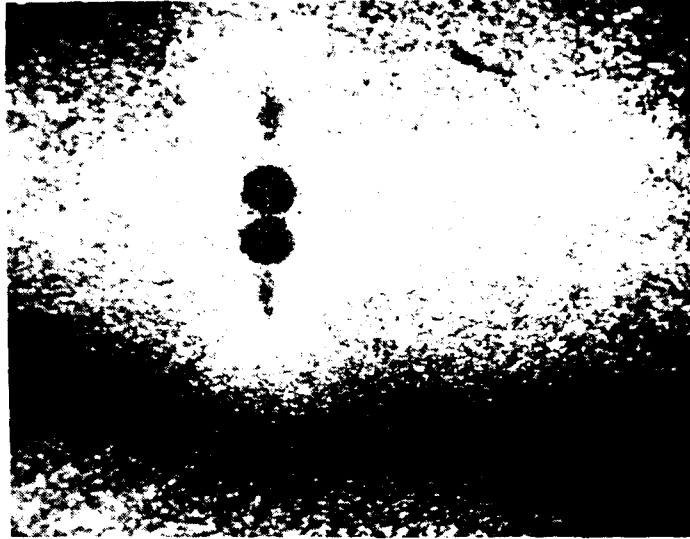
FIGURE 28. SMALL FATIGUE CRACKS AROUND PANEL RIVET HOLE. Y-VECTOR SHEAROGRAPH WITH CRACK MEASURING ABOUT 0.375 INCHES.

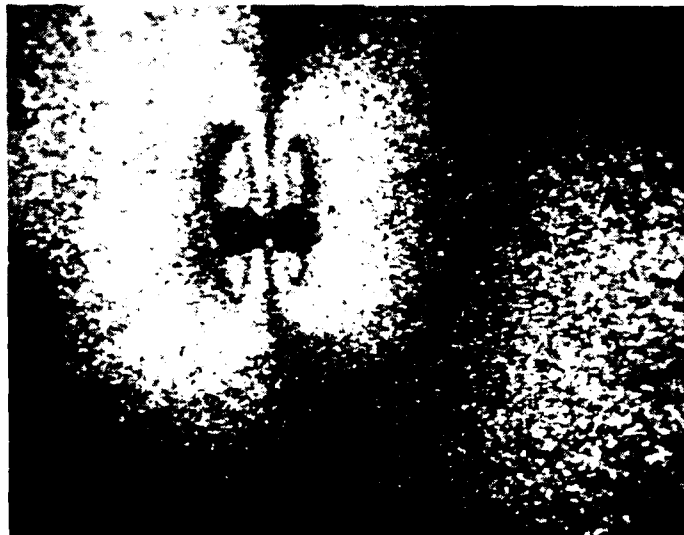
FIGURE 29. X-VECTOR SHEAROGRAPH SHOWING STRAIN CONCENTRATIONS AROUND 0.375-INCH CRACKS.
